## BLAST TESTS OF EXPEDIENT SHELTERS

Cresson H. Kearny Conrad V. Chester

POR No. 6749

FINAL PROJECT OFFICERS REPORT - LN316

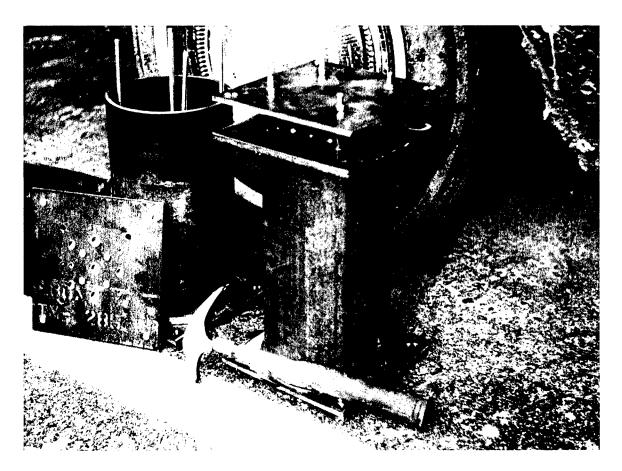
Figure 2.1 Yielding Foil Membrane Blast Gauges. An assembled and a partially dissembled gauge. Most gauges were set in the ground so that the middle rectangular plate was about one inch above ground level.

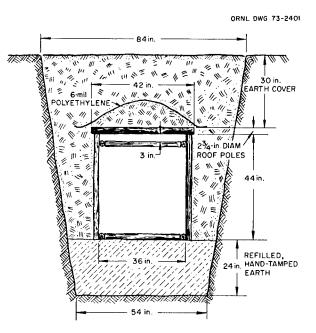
Figure 3.1 Vertical Section through Half-Scale Small-Pole Shelters LN316-1A and LN316-1B.

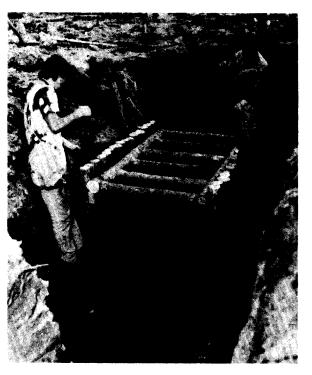
Figure 3.2 Frame and Side Walls of Half-Scale Small-Pole Shelter LN316-1A.

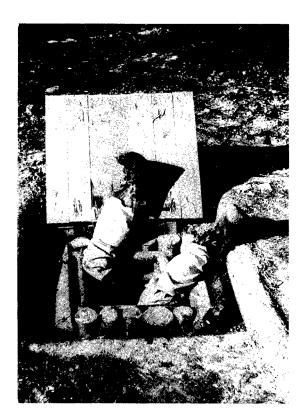
3.3.2 LN316-1A. The blast compacted the wet earth around the entryway and its blast-protection frame, but we could observe no significant removal of earth by the blast wind. See Figure 3.6. The blast

door (see Chapter 4) was undamaged. Inside the shelter, the most obvious result of the stresses caused by the blast was the squeezing together and slight inward bowing of almost all of the poles. Figure 3.7. No poles were cracked or otherwise damaged. The centers of the roof poles had a maximum depression of 2-1/2 inches and a permanent depression of 2 inches relative to bedrock. The elastic recovery of the roof poles was 1/2 inch, and the permanent downward bowing of the roof poles amounted to a scant 1/2 inch. Thus the wall poles had been forced downward about 1-1/2 inches into the rather soft, refilled earth. The expedient blast door remained held tightly closed by its undamaged auto-tire hinges and bridle wires.

Figure 3.6 Photographer upsidedown in Entryway of Half-Scale Small-Pole Shelter LN316-1A After the Blast. The fireball accompanying the 29 psi blast overpressure blackened the earth. The expedient blast door, the entryway, and the blast-protection frame of four notched-together logs were undamaged.

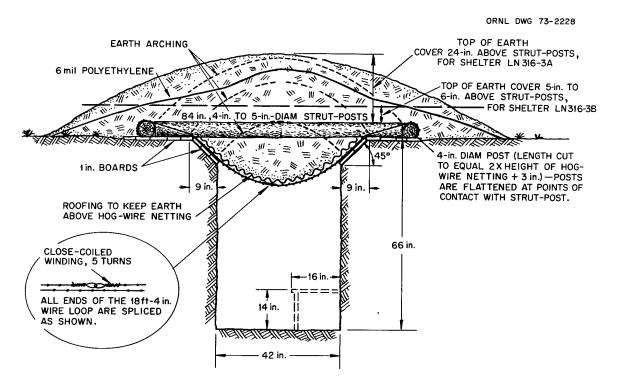
Figure 5.1 Wire-Catenary-Roofed Shelter.

No doubt the short duration of overpressures high enough to severely stress LN316-3B, combined with some earth arching in the "inadequate" earth covering of this shelter, caused the permanent downward deformation of its roof to be less than anticipated. As shown by Figure 5.1, the depth of earth in which arching could occur in LN316-3B is the vertical distance from the bottom of a 45° slope of unexcavated earth on which the roof wire rests, up to the

The blast overpressure further compacted the damp earth mounded over LN316-9, but, rather surprisingly, the blast wind removed very little of the wet earth from its mounded covering. The trench walls (which except for the uppermost 12 inches of sandy soil were of an earth that verged on a soft argillaceous sandstone) remained essentially unchanged. The center part of the wire "catenary" was depressed only about 1/4 inch relative to the "bedrock" floor of the shelter roomlet-indicating that very effective earth arching supported most of the surface load of about 29 psi overpressure. See Figure 5.1.

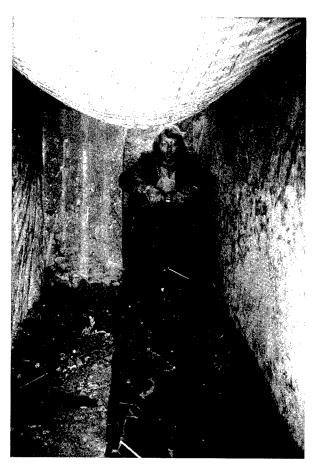
Neither of these closed shelters was consequentially damaged. The shock wave shook only very little earth from the trench walls, as is indicated in Figure 5.4 by the insignificant amount of fallen earth on the black plastic. Only after the earth cover was removed from around the frame posts was any damaged noted: one of the brittle cedar

strut-posts was found to be broken in two where its diameter suddenly changed (because of branching) from 5 inches to 3-1/2 in ches. However, the packed earth around this strut-post held the broken ends together so that it obviously continued to function effectively as a compression member of the frame.

Figure 5.4 Shelter LN316-3A After Withstanding an Outside Over-pressure of About 13 psi. The loaded wire-catenary roof exerted an outward pressure against both trench walls, increasing their stability.

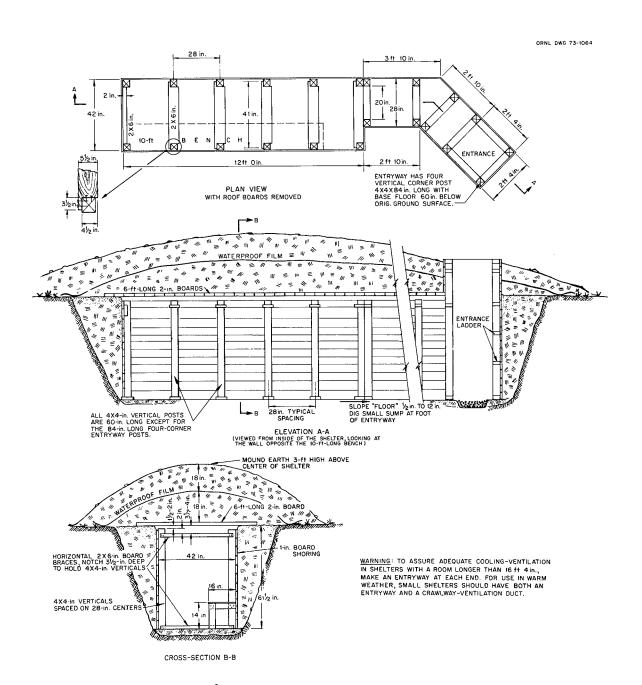
To limit the load on the shoring to the horizontal pressures of the earth pressing against it, the 6-foot-long, 2-inches-thick roofing boards rested only on the packed earth outside the shoring, and not on shoring boards. See Cross-Section B-B of Figure 6.1.

Figure 6.1 Shored-Trench Stoop-In Shelter.

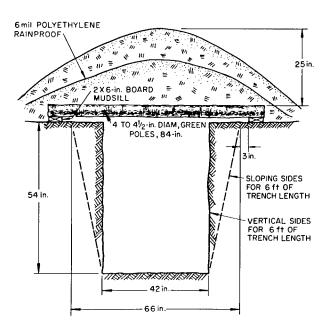
Figure 7.1 Log-Covered Trench Shelter LN316-9A. Note the mudsills under the ends of the minimum-sized roof "logs".

To obtain another measure of the effectiveness of earth arching, one of these shelters (LN316-4A) had the full earth cover shown in Figure 7.1. The earth was mounded 25 inches above the tops of the roof "logs", as measured after its compaction by the blast overpressures. The other shelter (LN316-4B) had the top of its blast-compacted earth cover only 8 inches above the roof "logs".

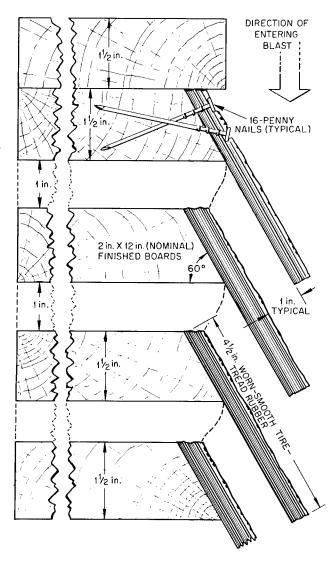
Figure 10.1 Vertical Cross Section Through an Overlapping-Flaps Blast Valve. The tested valve had four open air slots, each 1" high and 10" wide. The overall width of the housing was 18".

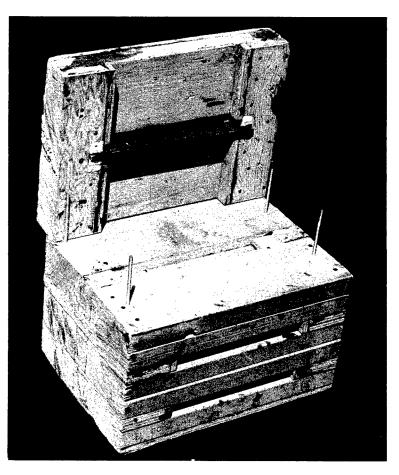
Figure B.1 Partly Disassembled Caged-Strips Blast Valve After Testing at the Measured 65 psi Range. Note the four sponge-rubber "springs" holding a plywood strip in its open position.

Upon disassembly, all the plywood strips and their steel springs and foam rubber "springs" were found to be in excellent working order. The bases of the foam rubber "springs" were still glued securely to the wood in their recesses. Only some thread-sized, blackened pieces of sagebrush had been blown around the two right-angle turns and far enough to reach the plywood strips. This very lightweight blastborne material did not interfere with the movement of the valves or their

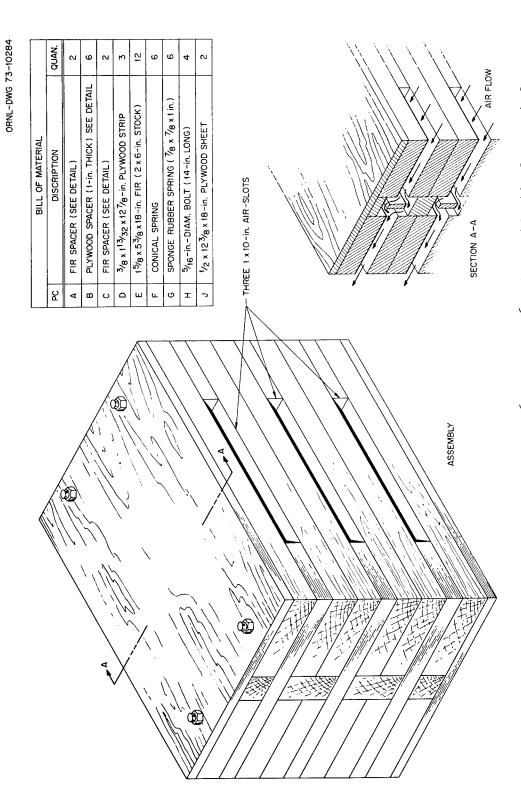
Figure B.2 Caged-Strips Blast Valve IN316-11B. IN316-11A was identical except for one of its "caged" plywood strips being 1/2-in. thick, instead of 3/8-in. thick.

The three 3/8-in.-thick plywood valve strips were all still in serviceable condition, but the center strip (one of the two painted with waterproofing "Resorcinol" resin glue) was cracked 1-1/4 inch from one end. This end had been slightly abraded--apparently from sticking on the somewhat rough end of its wooden "cage." The unpainted strip had been bowed about 1/8 inch out of line in its weak direction. This damage to two of the three strips indicates the need for smoothing all surfaces of the "cages" in which unattached valve strips should be able to move freely.

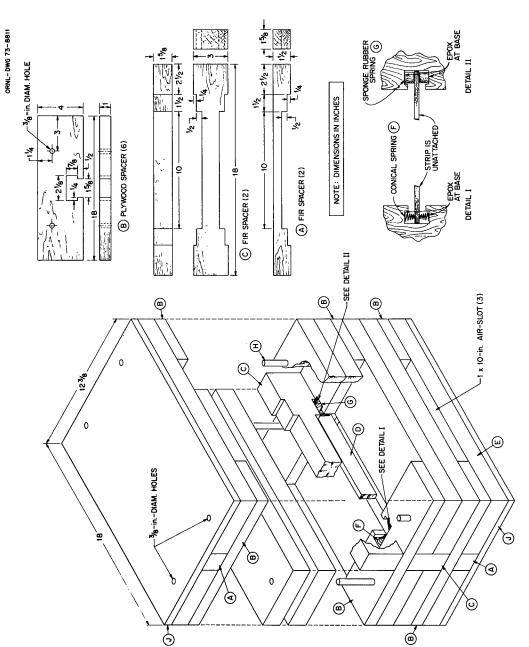
Figure B.3 Construction Details of Caged-Strips Blast Valve.
